Release Notes for MPiec controller firmware

Yaskawa America, Inc.

Release 3.1.0 builds 124,125, and 127

Sept. 10, 2015.

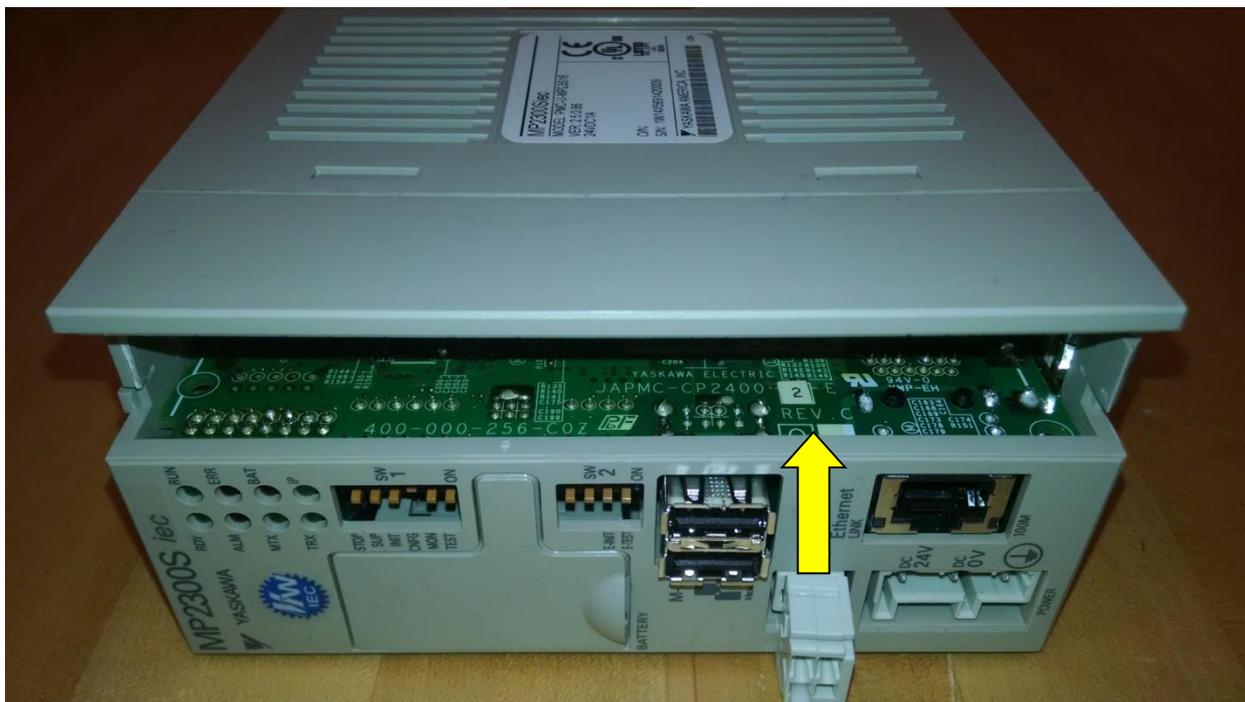
This release includes an Ethernet-related bug fix (8809) for the MP2300Siec and MP2310iec controllers with rev C hardware only. To determine if the MP2300 controller has rev C hardware, look at the silkscreen of the CPU board as shown below.
